CONFIDENTIAL INSPECTION REPORT

123 Pleasant, Anywhere, NY.

12/30/2003 3:30 pm to 5:30 pm

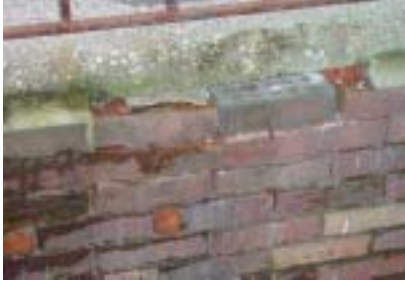
We noted defects in the brick entry. This is common and occasional servicing should be anticipated. At this time pointing (mortar repairs) are needed, some rebuilding of the front entry cannot be ruled out.

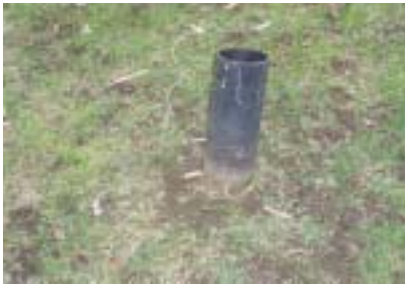
The exterior sewer vent cap is missing and should be replaced. Also the pipe itself is loose and may be separated at the sewer lateral.
